**THE BOX-BEAM BURSTER ENERGY ABSORBING
TUBE - BRIDGE PIER (BEAT-BP) PROTECTION SYSTEM**

Submitted to the Transportation Research Board for consideration for presentation at the Transportation Research Board Annual Meeting and publication in the Transportation Research Record.

ABSTRACT

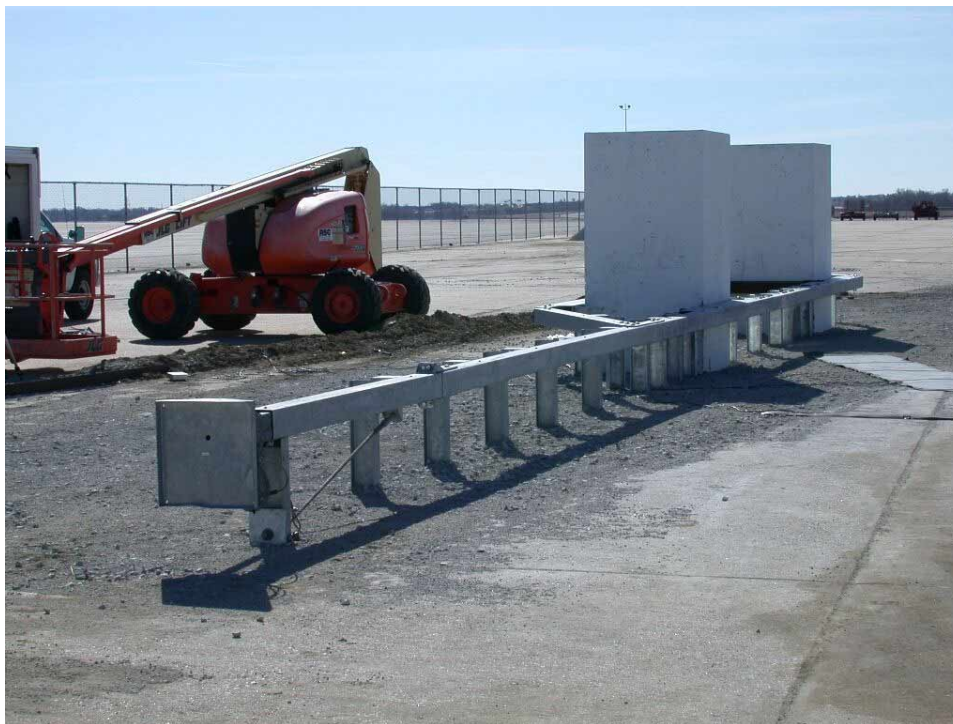
FIGURE 1: Photo of the Test Installation of BEAT-BP

The BEAT-BP protection system, as shown in Figure 1, consists of two BEAT energy absorbing crash cushions combined with a tubular structure around the bridge piers. The crash cushions provide protection for end-on impacts while the tubular structure shields the bridge piers from side impacts by errant vehicles. The tubular structure around the bridge piers is modular in nature and can be adjusted to accommodate different number, size, and spacing of bridge piers. The crash cushions are designed with two stages of energy absorption and sufficient capacity to absorb the kinetic energy of a 2000-kg (4,409-lb) pickup truck impacting at a nominal speed of 100 km/h (62.2 mph). Note that the length of the stage 2 energy absorbing tube may be lengthened to increase the capacity of the crash cushion to handle higher energy impacts.

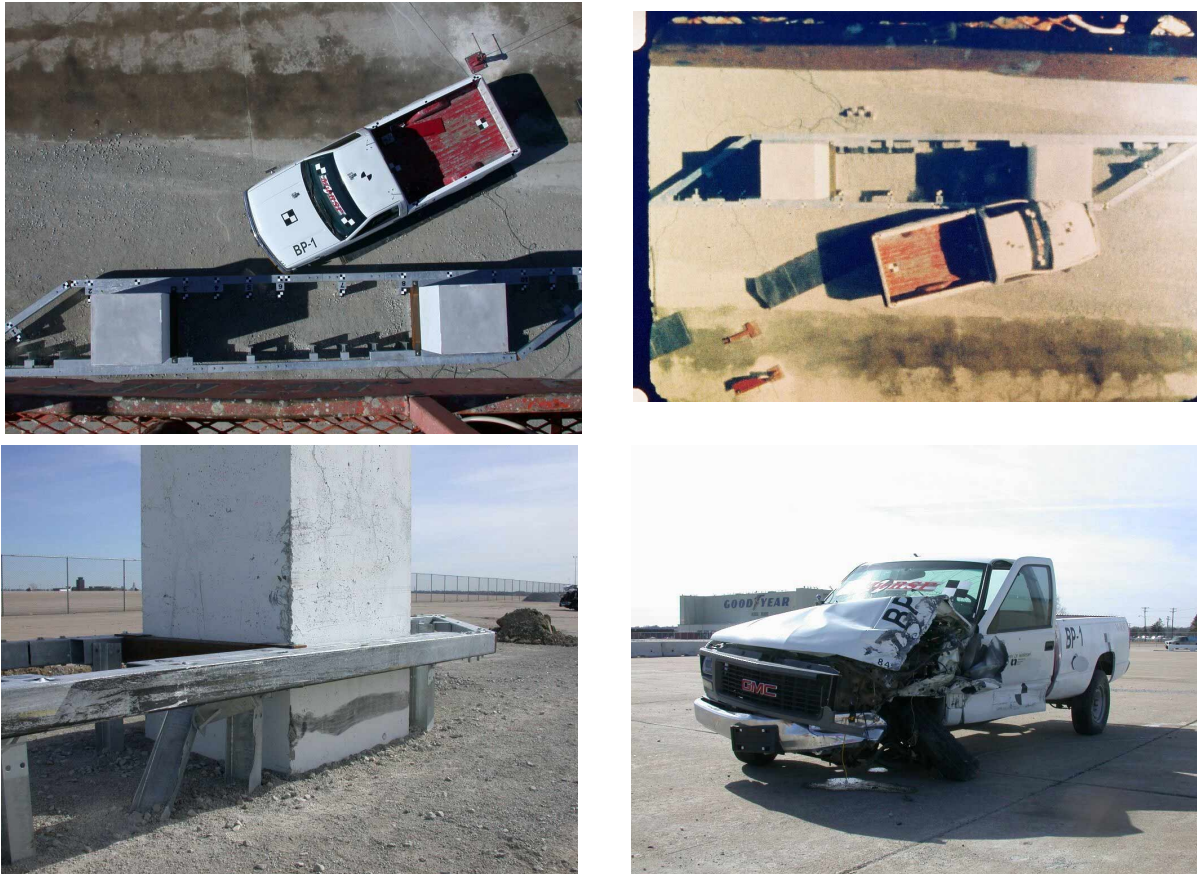
FIGURE 3: Pre-test and Post-test Photos of BP-1

runs, to be 152-mm (6 in.) upstream of post no. 13 so as to produce the maximum dynamic deflection at the downstream bridge pier. The vehicle impacted the crash cushion at a speed and angle of 98.6 km/h (61.3 mph) and 25.3 degrees. Pre-test and post-test photos are shown in Figure 3.

Upon impact, the left-front corner of the pickup truck deformed inward and vehicle began to be redirected by the box beam rail. As the rail deformed the front-left fender of the vehicle inward, the hood and part of the fender protruded over the rail. The left front wheel slid underneath the box beam rail and snagged on post 15, causing the post to bend towards and impact post 16. The left-front corner of the hood that extended over the rail impacted the downstream bridge pier causing the hood to deform and be pushed back towards the windshield. The left front fender also snagged on the bridge pier and deformed backwards. The vehicle continued to redirect and eventually lost contact with the system 4.19 m (13 ft 9 in.) downstream of the impact point. The vehicle veered to the left after leaving the system and came to rest 39 m (128 ft) downstream and 6.2 m (20 ft) to the left of the impact point.

Damage to the test installation was moderate, including the posts, the box-beam rail, and the downstream bridge pier. Post 15 was bent and twisted over at the ground line due to snagging by the left-front wheel. Post 16 was also bent downstream. Damage to the box-beam rail was limited to a slight bend between posts 14 and 15 and contact marks. Minor cosmetic damage was also observed on the downstream bridge pier. The maximum dynamic deflection of the system was measured to be 52-mm (2 in.).

Vehicle damage was extensive, including the left front corner and fender of the vehicle, and driver's side door. The hood was buckled upward and pushed back towards the windshield, which was deformed and cracked. The left-front wheel was pushed inward and back to the firewall causing damage to the suspension. There was significant damage to the occupant compartment, including a large tear of the seam on the front of the floor pan underneath the brake pedal and deformations to the floor pan and the dash. The maximum deflection was measured to be 191 mm (7.5 in.) laterally and 178 mm (7 in.) vertically. The occupant risk factors are well within limits set forth in NCHRP Report 350 guidelines.

This test was judged to be a marginal pass according to evaluation criteria set forth in NCHRP Report 350. The test article contained and redirected the impacting vehicle and the vehicle did not penetrate, underide, nor override the barrier. There were minimal detached elements and debris. The vehicle remained upright during and after the collision. The vehicle's trajectory did not intrude into adjacent traffic lanes. The occupant impact velocities and ridedown accelerations were within the suggested limits imposed by NCHRP Report 350.

However, several concerns were raised during analysis of the test results that rendered the test a marginal pass:

1. Minor windshield cracking due to snagging of the hood and front-left fender on the bridge pier was observed.
2. Occupant compartment deformations observed in the test were as large as 191 mm (7.5 in.) laterally and 178 mm (7 in.) vertically. FHWA has recommended that occupant compartment deformations of more than 150 mm (6 in.).

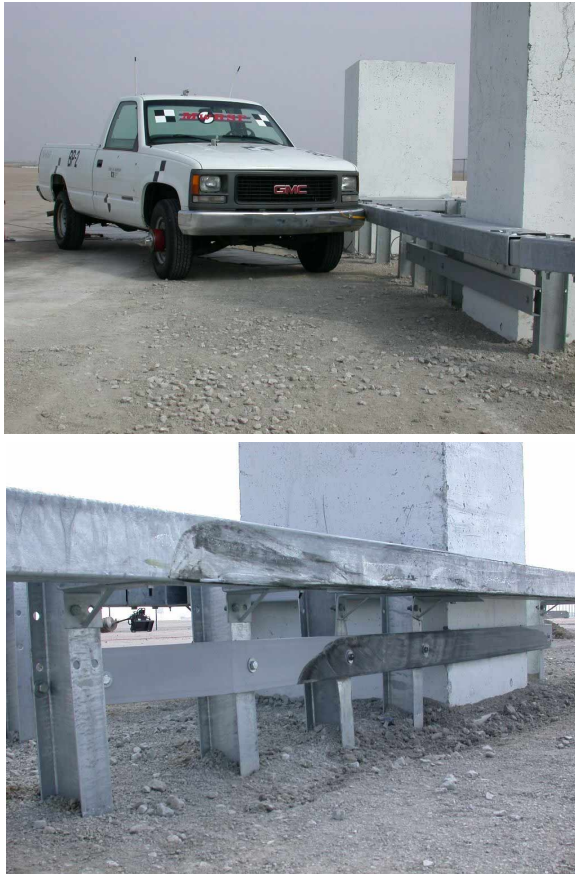
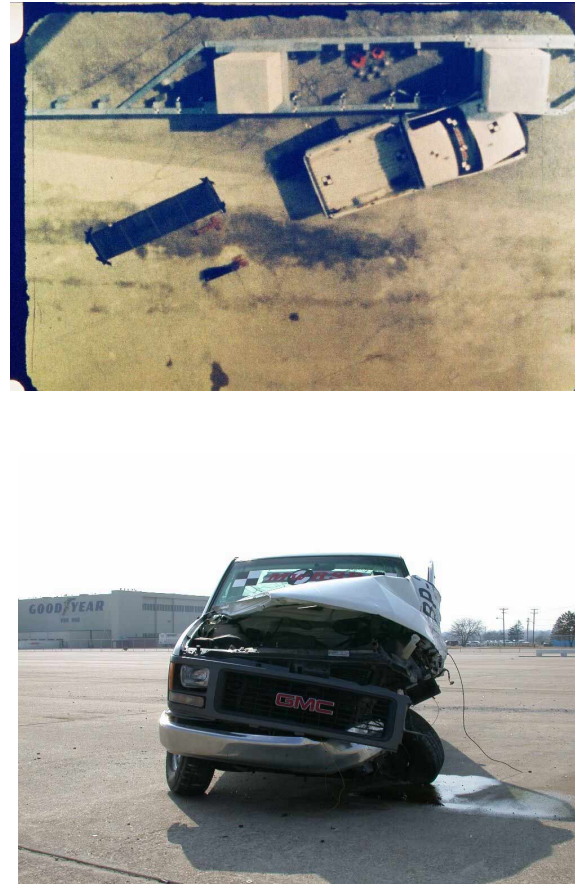
FIGURE 4: Pre-test and Post-test Photos of BP-2

This test is a repeat of test no. BP-1, i.e., pickup truck transition CIP test (NCHRP Report 350 Test Designation 3-21), with the added channel rubrail. The point of impact was again selected to be 152-mm (6 in.) upstream of post 13 so as to produce the maximum dynamic deflection at the downstream bridge pier. The vehicle impacted the crash cushion at a speed and angle of 100.5 km/h (62.5 mph) and 23.7 degrees. Pre-test and post-test photos are shown in Figure 4.

Upon impact, the left-front corner of the pickup truck deformed inward and the vehicle began to be redirected by the box beam rail. As the rail deformed the front-left fender of the truck inward, the hood and part of the fender protruded over the rail. The left front wheel pushed up against the channel rubrail and the tubular frame of the crash cushion began to deflect inward. The left-front corner of the hood that extended over the rail impacted the downstream bridge pier causing the hood to deform and be pushed back towards the windshield. The left front fender of the pickup truck also snagged on the bridge pier and deformed backwards as well. However, there was little or no snagging of the front-left wheel on the posts or the bridge pier due to the channel rubrail. The pickup truck continued to redirect and eventually lost contact with the system 4.19 m (13 ft 9 in.) downstream of the impact point. The vehicle veered to the left after leaving the rail and came to a stop 41 m (135 ft) downstream and 4.8 m (16 ft) to the left of the impact point.

Damage to the test installation was moderate, including the posts, the box-beam rail, the channel rubrail, and the downstream bridge pier. Posts 12 through 14 displayed minor lateral deflections in the soil while posts 15 and 16 were twisted counterclockwise in the soil. Damage to the box-beam rail and the channel rubrail was limited to slight bends in the rail and contact marks along the rail. Minor cosmetic damage was also observed to the downstream bridge pier. The maximum dynamic deflection of the system was measured to be 141 mm (5.6 in.).

Vehicle damage was extensive, including the left front corner and fender of the vehicle, and driver's side door. The hood was buckled upward and pushed back towards the windshield, which was deformed and cracked. The left-front wheel was pushed inward and back to the firewall causing deformation of the tie-rods and other suspension components. The left-front tire was deflated.

Significant damage was observed to the occupant compartment of the vehicle, including a large tear of the seam on the front of the floor pan underneath the brake pedal and deformations to the floor pan and the dash. The maximum deflection was measured to be 267 mm (10.5 in.) laterally. The windshield was deformed and fractured due to impact by the hood. The occupant risk factors are within limits set forth in NCHRP Report 350 guidelines.

This test was judged to be unacceptable based on the two following factors:

1. There was significant snagging of the hood and the front-left fender on the bridge pier. The hood was pushed backward into the windshield, resulting in unacceptable damage to the windshield.

2. There was significant occupant compartment deformation of up to 267 mm (10.5 in.) laterally. FHWA has recommended that occupant compartment deformations of more than 150 mm (6 in.) in a location where serious injury can result are cause for judging a test as unacceptable. Therefore, the large occupant compartment deformations observed in this test was judged not acceptable.

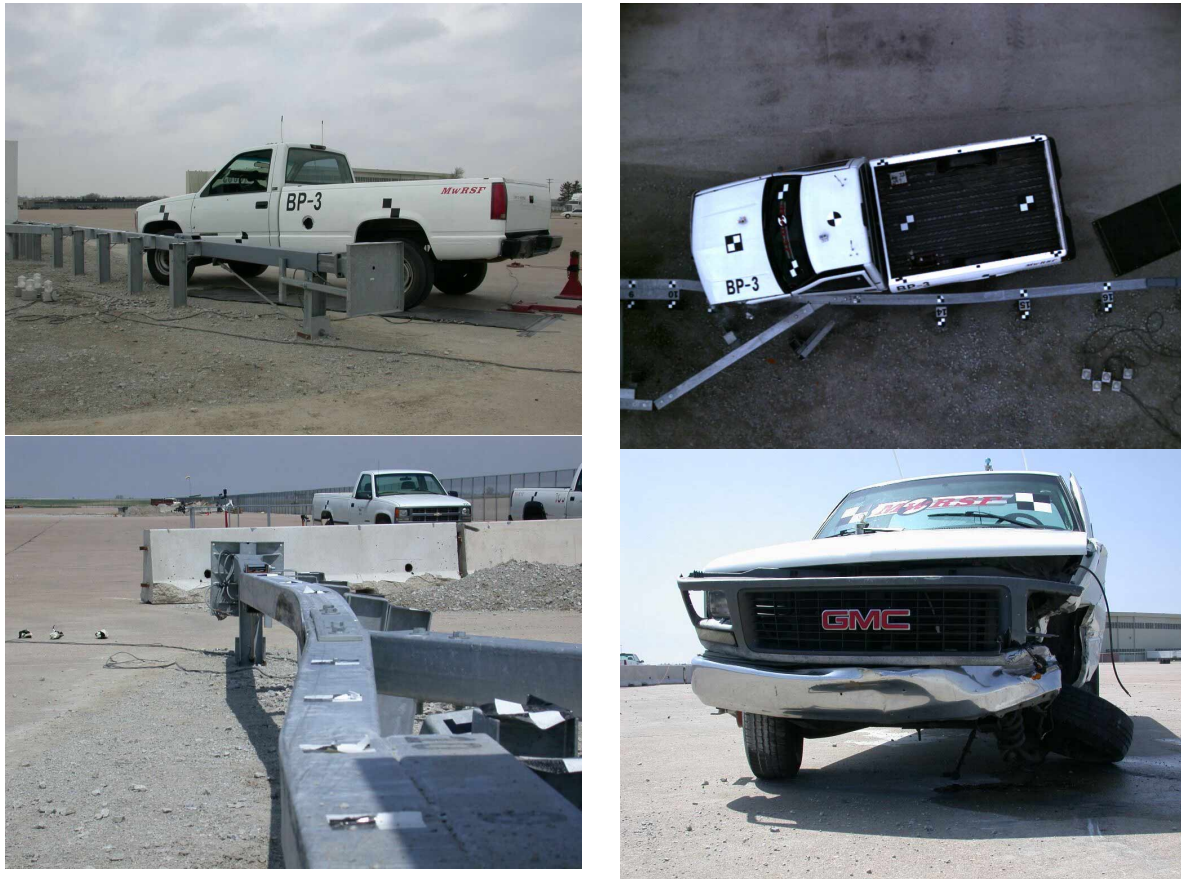
FIGURE 5: Pre-test and Post-test Photos of BP-3

The third test conducted was the pickup truck CIP test, sometimes referred to as the “coffin-corner” test (NCHRP Report 350 test designation 3-38). Note that the system design reverted back to the original design used in test no. BP-1 without a rub rail since the modified system design used in test no. BP-2 did not perform satisfactorily. The CIP was determined, based on results of BARRIER VII simulation runs, to be at post 4 so as to produce the maximum dynamic deflection at the hard point, i.e., the Y-connector joining the end of the crash cushion, the box-beam rail on the front side, and the diagonal rail from the back side. The vehicle impacted the crash cushion at a speed and angle of 101.4 km/h (63.0 mph) and 20.7 degrees. Pre-test and post-test photos are shown in Figure 5.

Upon impact, the left-front corner of the vehicle was deformed inward and the box-beam rail was deflected back and began to redirect the vehicle. As the rail deformed the front-left fender of the truck inward, the hood and part of the fender protruded over the rail. The left-front wheel of the vehicle slid underneath the box-beam rail, turned to the left, and snagged post 6, causing the tire to deflect and the post to fracture. The vehicle continued to move downstream and smoothly traversed the Y-connector. The left-front wheel of the vehicle then snagged post 7. The vehicle lost contact with the system 5.8 m (19 ft) downstream of the impact point. The vehicle veered to the left after leaving the rail and came rest 45 m (148 ft) downstream and 4.5 m (14.7 ft) to the left of the impact point.

Damage to the test installation was moderate, consisting of damage to the posts and the box-beam rail. Post 6 fractured at ground level due to snagging by the front-left wheel and was deposited 6.7 m (22 ft) downstream and 4.6 m (15 ft) to the left of its original position. Deformation of the box-beam rail was observed from post 4 through 9, and buckling was observed in the rail at post 9. A maximum indentation of 9.5 mm (0.4 in.) was found 610 mm (24 in.) downstream of post 4. The maximum dynamic deflection of the system was measured to be 311 mm (12.2 in.).

Vehicle damage was moderate, including the left front corner and fender of the vehicle, and the driver’s side door. Significant damage of the front-left portion of the frame of the pickup truck was observed. The front-left wheel was detached and the suspension was disengaged from

the frame. The front-left tire was also deflated. Minor deformations of both the floor pan and the dash of the vehicle were observed. The maximum deflection was 83 mm (3.3 in.) vertically near the middle of the driver's side floor pan. The windshield displayed some minor cracking. The occupant risk factors are well within limits set forth in NCHRP Report 350 guidelines.

This test was judged to be acceptable in accordance with evaluation criteria set forth in NCHRP Report 350. The test article contained and redirected the impacting vehicle and the vehicle did not penetrate, underide, nor override the barrier. There were minimal detached elements and debris. There was no significant deformation or intrusion into the occupant compartment. The vehicle remained upright during and after the collision. The vehicle's trajectory did not intrude into adjacent traffic lanes. The occupant risk factors were within suggested limits set forth in NCHRP Report 350.

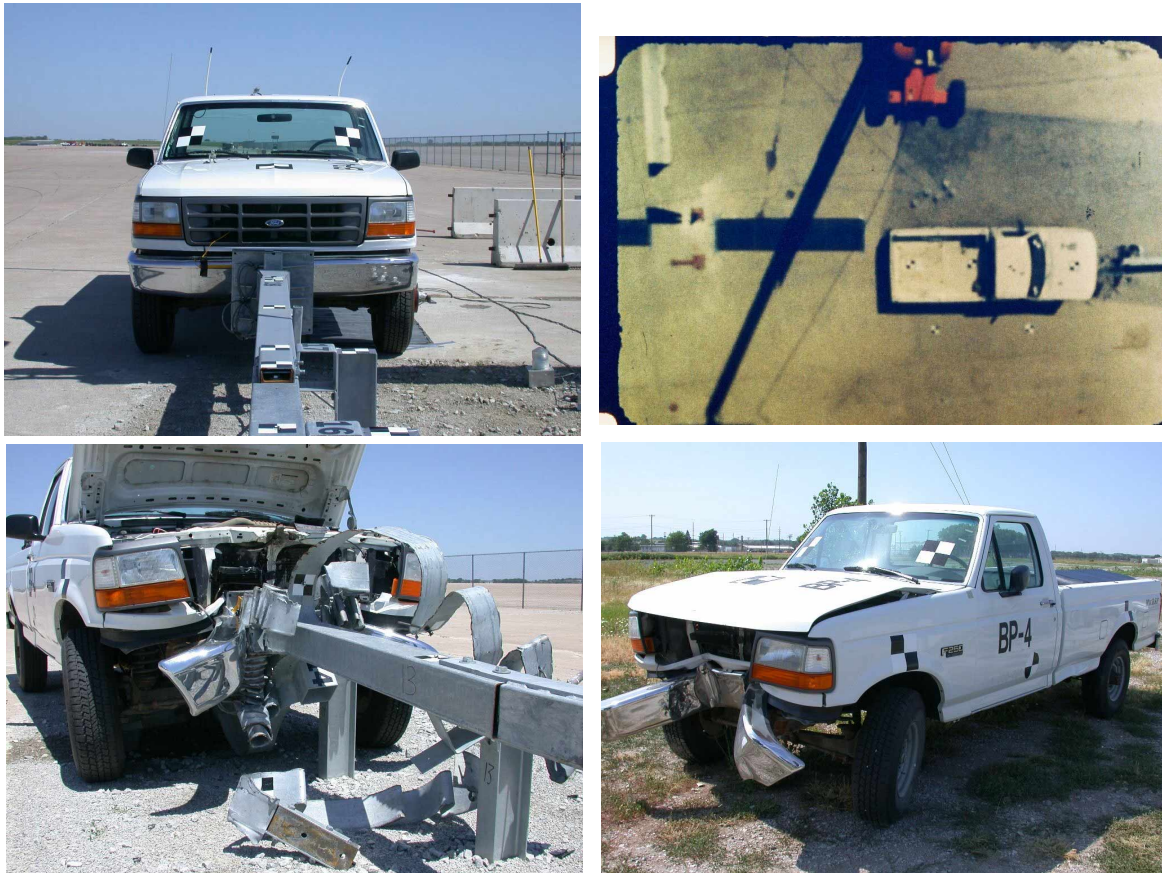
FIGURE 6: Pre-test and Post-test Photos of BP-4

The fourth and last test conducted was the pickup truck head-on test (NCHRP Report 350 test designation 3-31). The vehicle impacted the crash cushion at a speed and angle of 102.0 km/h (63.4 mph) and 0.6 degree. Pre-test and post-test photos are shown in Figure 3. During this test, the terminal decelerated the vehicle and brought the vehicle to a safe and controlled stop 6.4 m (21 ft) downstream from the impact point.

The terminal performed as designed. Upon impact, the front of the vehicle engaged and mechanically interlocked with the impact head. As the vehicle proceeded forward, the post breaker broke off the end post and initiated the bursting process with the stage 1 energy absorbing tube. The stage 1 energy absorbing tube was completely bursted and the bursting process continued with the stage 2 energy absorbing tube until the vehicle came to a safe and controlled stop against the impact head past post 5. The occupant risk factors were all well within the recommended limits.

Damage to the BEAT-BP crash cushion was moderate, consisting of damage to the posts and the box-beam rail. Posts 1 through 3 were fractured at ground level and post 4 was bent over, but did not fracture. The total bursted length was 5.96 m (19 ft 7 in.), including all 2.44 m (8 ft) of the stage 1 energy absorbing tube and 3.52 m (11 ft 7 in.) of the stage 2 energy absorbing tube. Bursting of the tubes through splice connecting the two tubes caused strips of metal from the stage 1 tube and parts of the splice joint to be disengaged from the system. The system anchorage remained intact, and there was no significant damage to the impact head assembly.

Vehicle damage was moderate and limited to the frontal area. There were minor deformations in both the floor pan and the dash areas. The maximum deflection was 19 mm (3/4 in.) vertically near the front-left side of the hump in the driver's side floor pan and longitudinally. The occupant risk factors were within limits set forth in NCHRP Report 350.

This test was judged to be acceptable in accordance with evaluation criteria set forth in NCHRP Report 350. The test article safely brought the impacting vehicle to a controlled stop. Detached elements and debris from the test installation did not penetrate nor show potential for penetrating the occupant compartment or present undue hazard to the other traffic, pedestrians, or personnel in the work-zone. There were only minor deformation and intrusion of the occupant compartment. The vehicle remained upright during and after the collision. The vehicle's trajectory did not intrude into adjacent traffic lanes.
